Manhole Inspection Summary

Manhole # S37CC_024MH

Location Address: **1007 BRENTWOOD AVE**

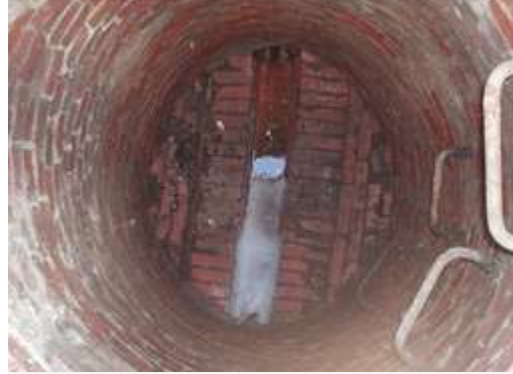
Top View

Corroded steps. Bench debris.

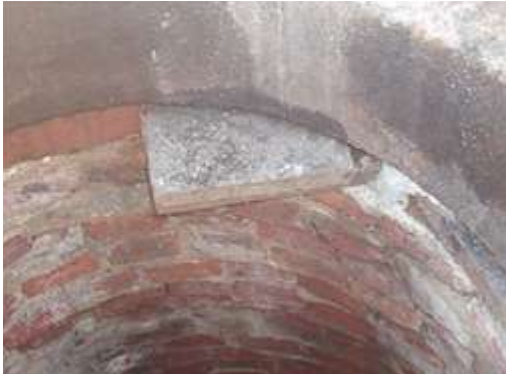
Defect

Frame leaks. Frame offset. Adjustment deterioration, loose brick and infiltration. Corbel infiltration.

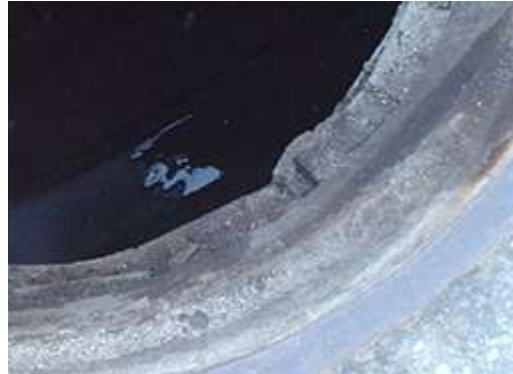
Defect

Frame leaks. Frame offset. Adjustment deterioration and infiltration.

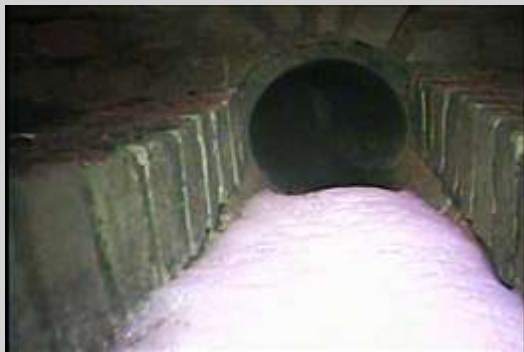
8 in. Circular Gravity Sewer Pipe Out @ 12 O'Clock

Channel deterioration.

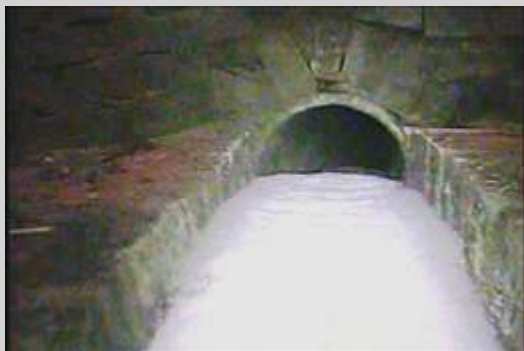
8 in. Circular Gravity Sewer Pipe In @ 7 O'Clock

Infiltration: **Evidence** Pipe Seal Cond: **Unknown**
